Manhole Inspection Summary

Manhole # S71E1_001MH

Insp Date: **2/13/08 1:08 PM**

Location Address: **6541 Saint Helena Ave.**

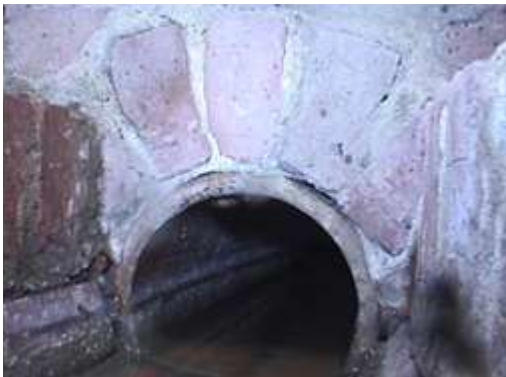
Defect 1

cracked seal pipe 1 to the 2 on the 9oclock incoming connection

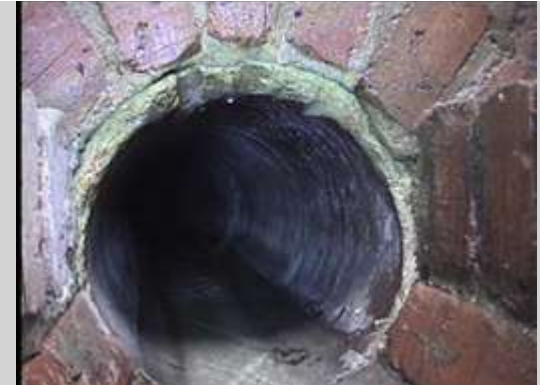
12 O'Clock Outflow

8 in. Circular Gravity Sewer
Pipe Out @ 12 O'Clock

Infiltration: **None** Pipe Seal Cond: **Sound**

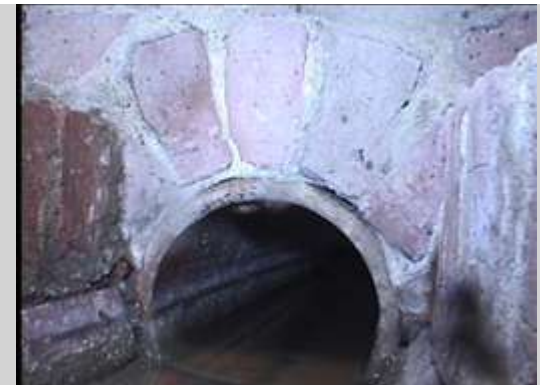
9 O'Clock Inflow

6 in. Circular Gravity Sewer
Pipe In @ 9 O'Clock

Infiltration: **None** Pipe Seal Cond: **Sound**
